# **CORROSION TESTING OF ADVANCED COATINGS IN ACCORDANCE WITH HARD CHROME ALTERNATIVES TEAM ACTUATOR JOINT TEST PROTOCOL**

Robert B. Mason, Martin Konrad, and Mark F. Singleton, Ph.D.  
Concurrent Technologies Corporation

**Hard Chrome Alternatives Team Meeting  
San Diego, CA – January 24, 2006**

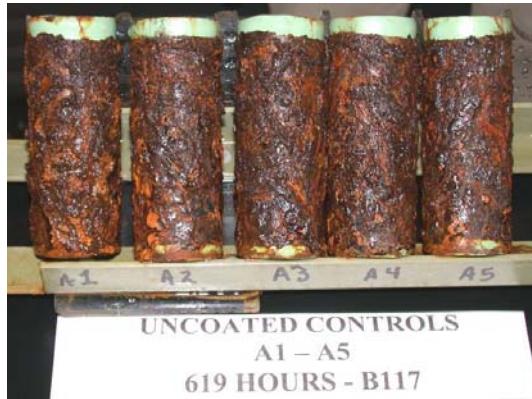
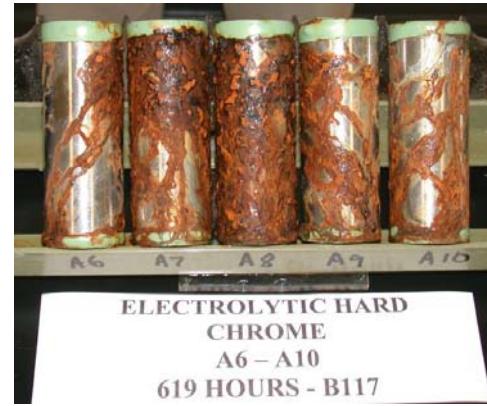
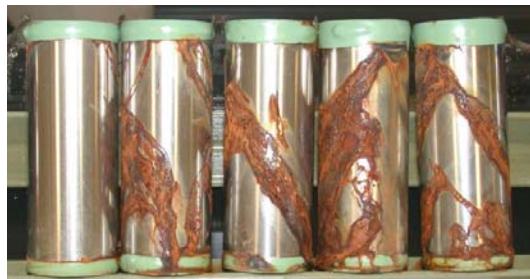
- TDPM<sub>D</sub> specimens after 619 hours of B117

- Uncoated and EHC-plated shafts exhibited high corrosion rates, as expected
- COTS TS provided improved protection when compared to uncoated and EHC
- COTS ST provided improved performance to EHC
- COTS EN exhibited significant corrosion
- Corrosion performance enhancement of TS and ST specimens over EHC is evident

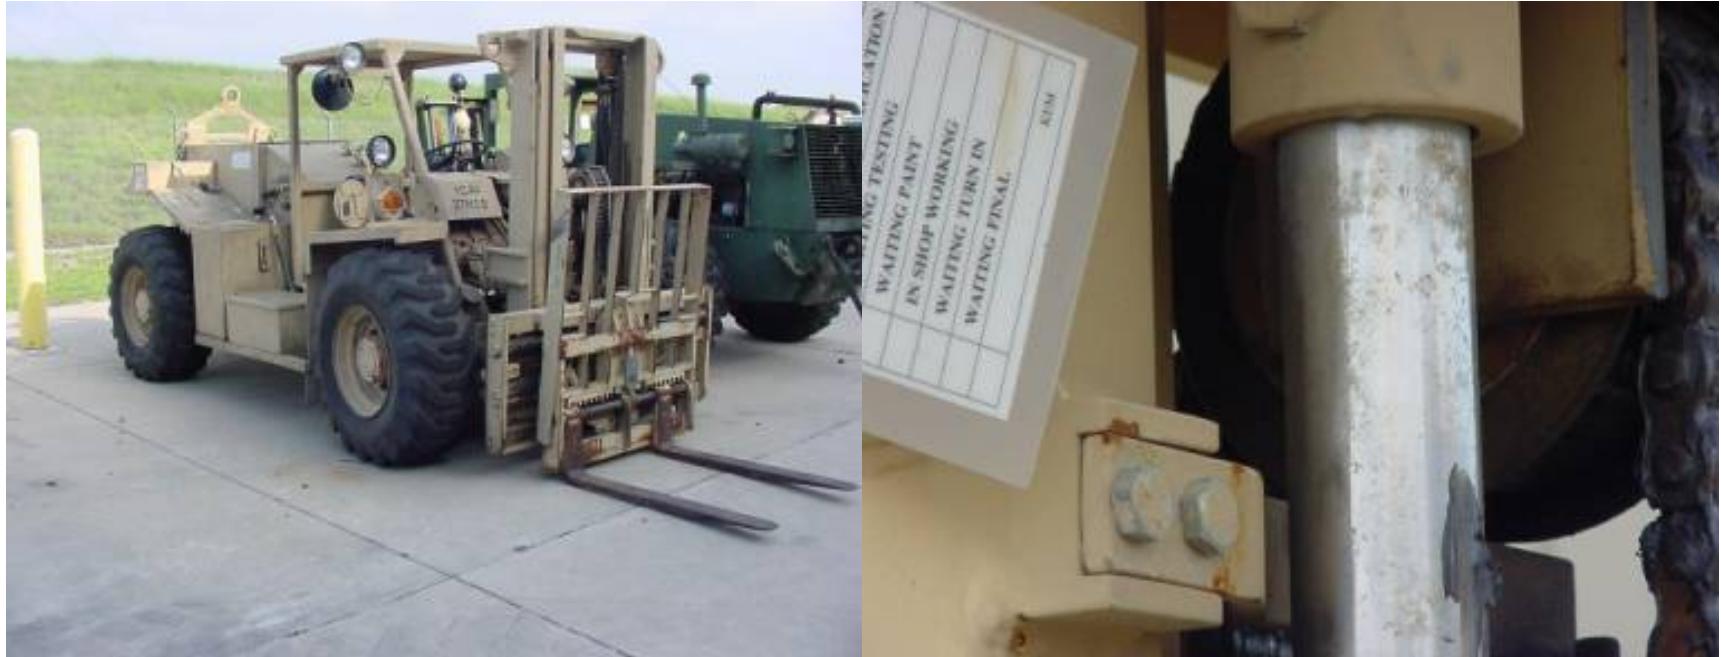
- Corrosion on Actuator of M4K Tactical Forklift

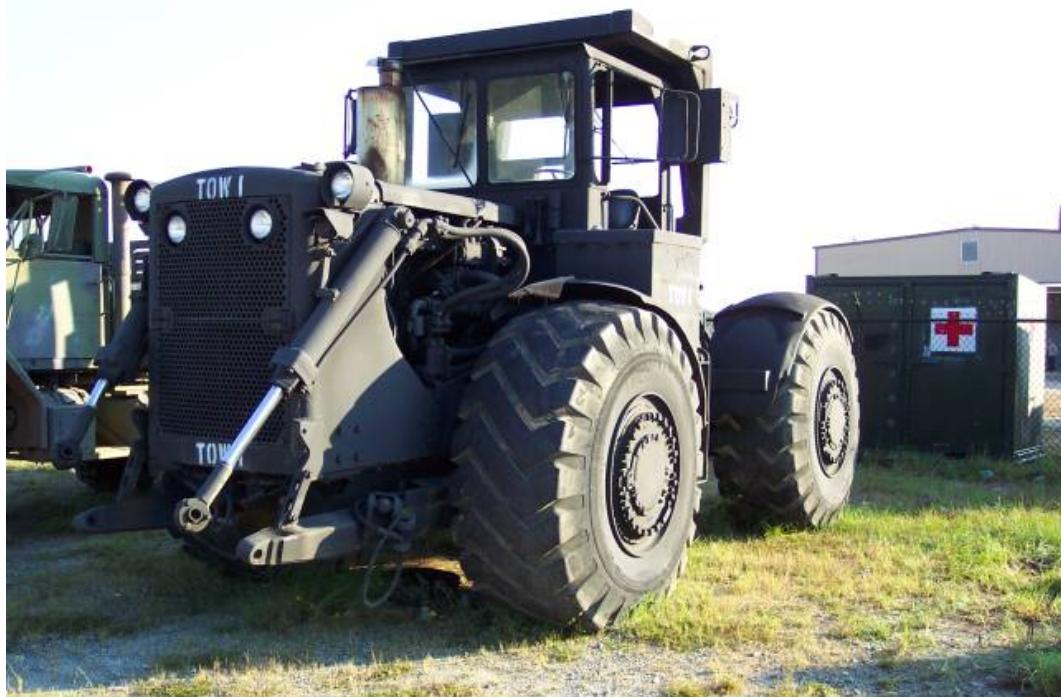
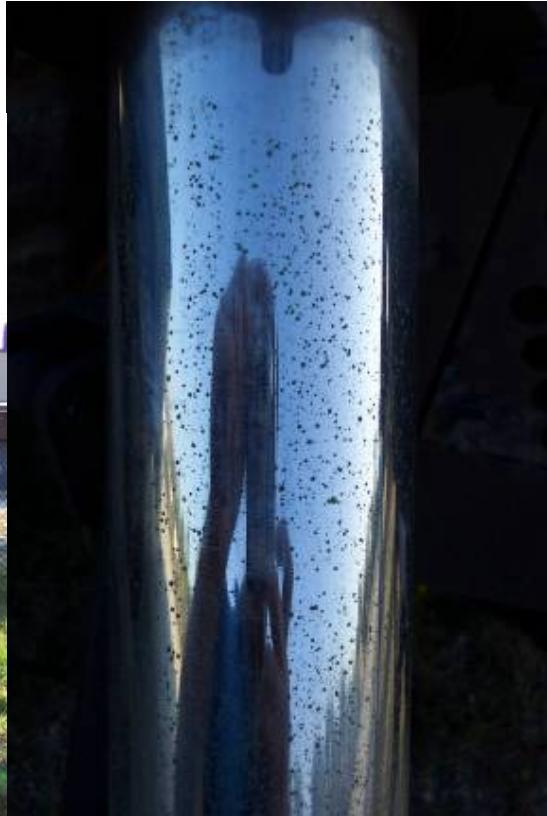
- Pitting Corrosion on Actuator on Wheeled Tractor

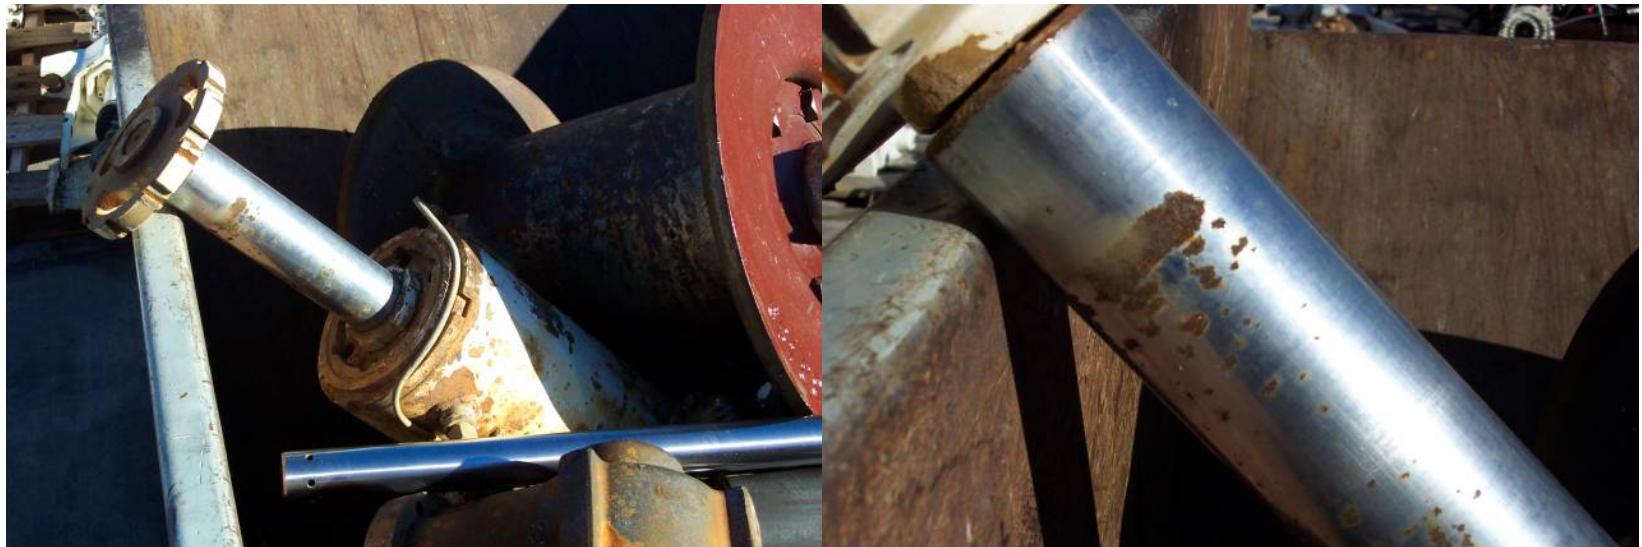
Corrosion on Hydraulic Actuator

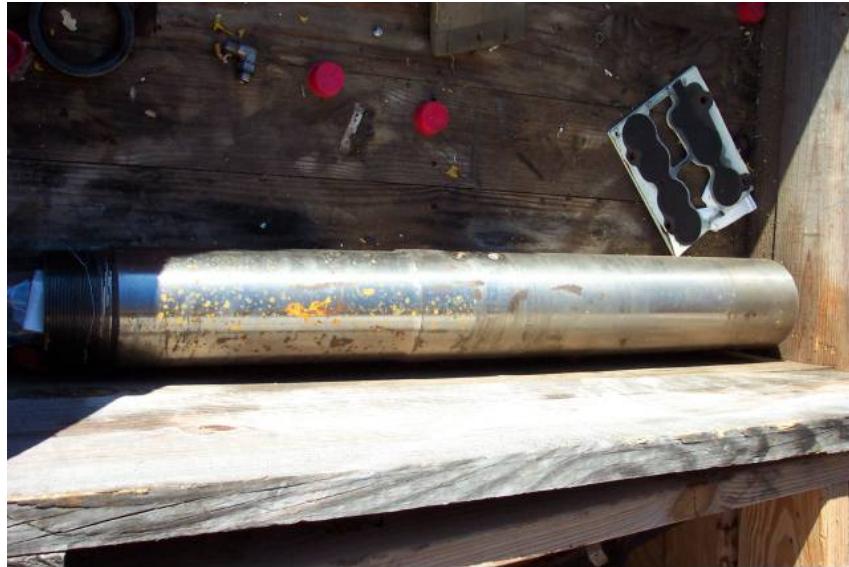
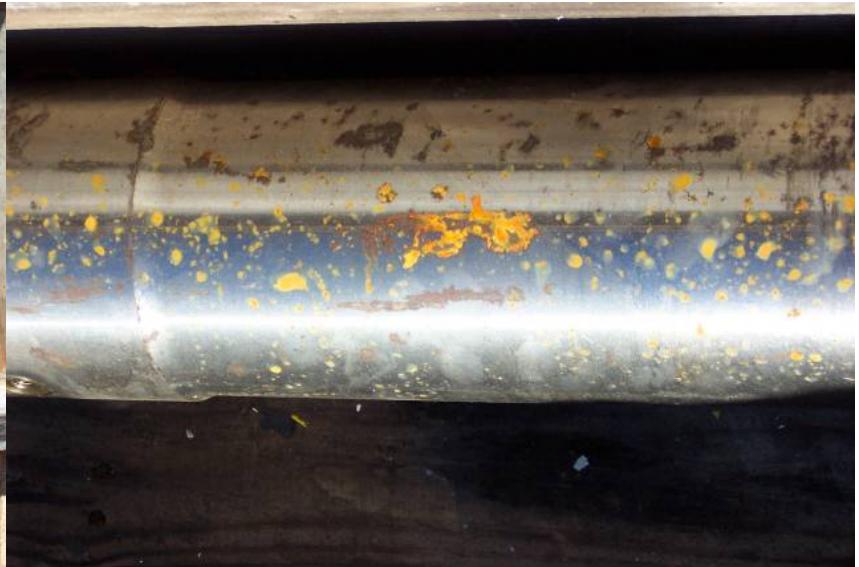
Corrosion on Hydraulic Actuator
